**03-002/14 - 2013-2014 CX-5 - RATTLE / CHATTER NOISE FROM REAR DIFFERENTIAL**

<b>Subject:</b> <b>RATTLE / CHATTER NOISE FROM REAR DIFFERENTIAL</b>	<b>Bulletin No:</b> 03-002/14
	<b>Last Issued:</b> 05/13/2014

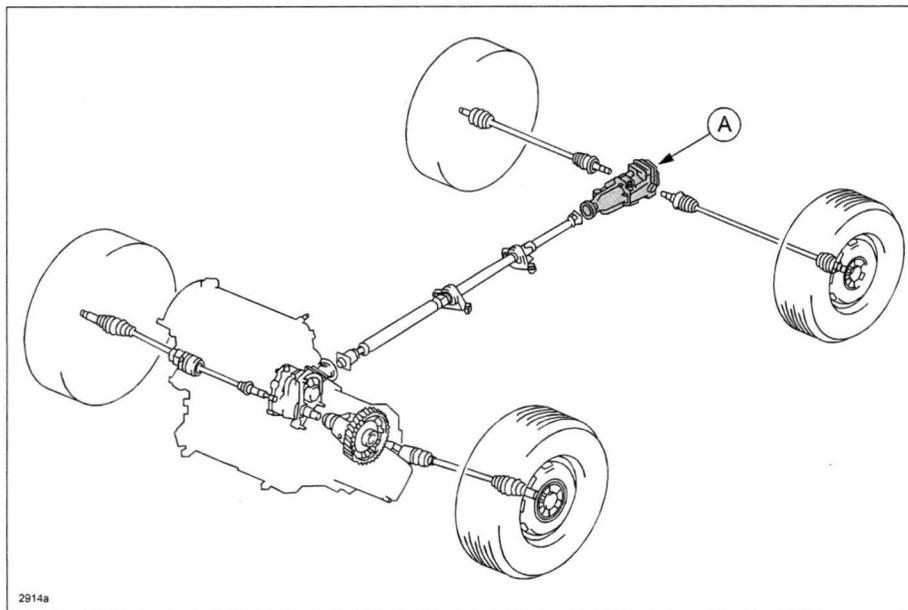
While driving at low speeds, some vehicles may exhibit a chattering/rattling type noise from the rear of the vehicle. A rear differential component, internal bearing noise, may be the cause.

1. Lift the vehicle. Refer to MS3 online (section 00-00 JACKING POSITIONS, VEHICLE LIFT (2 SUPPORTS) AND SAFETY STAND (RIGID RACK) POSITIONS).
2. Verify if the noise is heard from the rear differential component (A) when the wheel speed is approximately 3 to 6 mph (5 to 10 km/h).

3. Has the noise been verified?
  - a. Yes - Proceed to step 4.
  - b. No - This bulletin does not apply. Refer to MS3 online or Workshop Manual (section 03-03 NO.3 ABNORMAL NOISE AND/OR VIBRATION FROM COUPLING COMPONENT).
4. Contact MASH at 888 832-8477, option 2, to obtain authorization to replace the rear differential component (including the coupling unit). Refer to MS3 online or Workshop Manual (section 03-14 REAR DIFFERENTIAL REMOVAL/INSTALLATION).

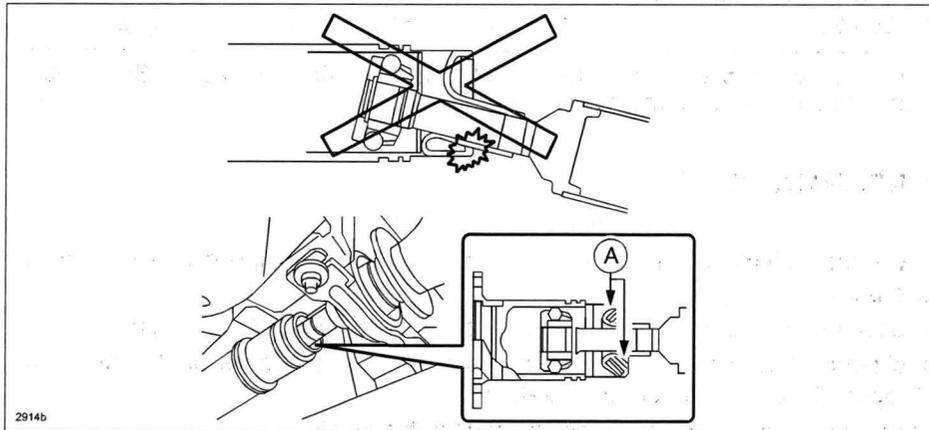
**CAUTION:** If the constant velocity joint angle is excessive during propeller shaft removal/installation, the constant velocity joint boot may be damaged when contacting the metallic cover. Protect the constant velocity joint boot by inserting a shop rag (A) between the boot and the metallic cover.
